NEW BEGINNINGS PROPERTY INSPECTION REPORT

Inspection Property Address
Anywhere, IN Zip Code

Sample Report

NOVEMBER 12, 2020

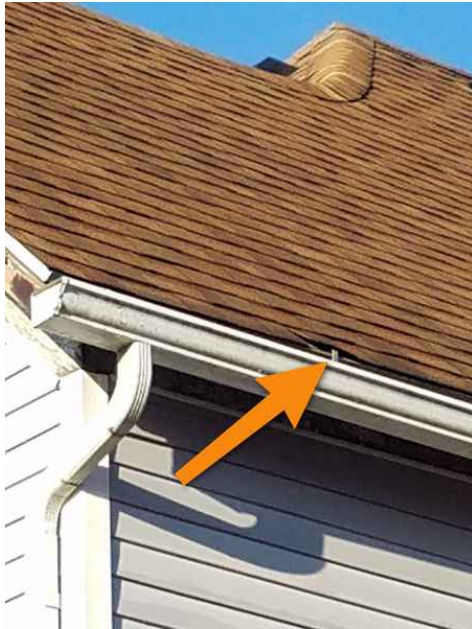
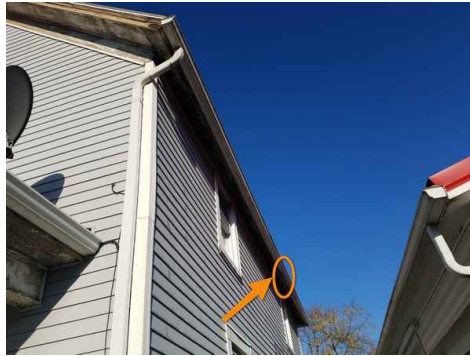
GUTTER FASTENING DEFECT

I observed indications of a defect at the gutter fastening. This will allow for water penetration to the foundation. Recommend a reputable contractor.

Gutter Hanger

Rust

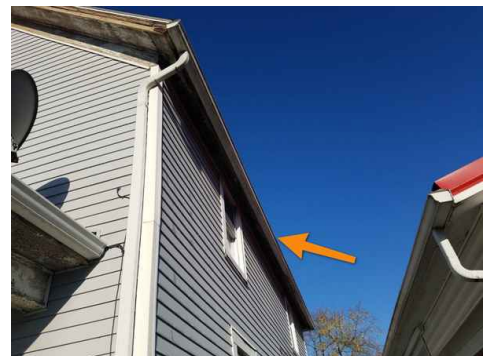
2.2.2 Gutters & Downspouts

GUTTER IMPROPERLY SLOPED

Gutters show indications of improper slope. Gutters are supposed to be sloped down toward the downspout of the gutter. That would be proper drainage of the gutter. This gutter sags in the middle in between the upper windows. This will allow for water penetration to the foundation. Recommend a reputable contractor.

Sloped to Center

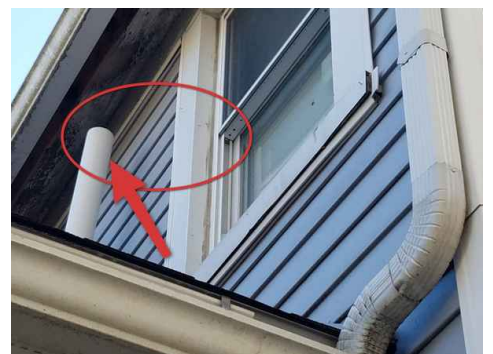
2.4.1 Plumbing Vent Pipes

The plumbing vent termination point has to adhere to certain criteria. Termination point needs to be 6 inches above nearest roof surface, 12 inches from nearest vertical surface, and 10 foot horizontally from or 2 foot vertically above nearest opening back into the home; for example a window or a door of a home. This will allow methane gas to enter the home. Recommend a reputable licensed plumbing contractor.

Plumbing vent too close to window.

Recommendation
Contact a qualified professional.

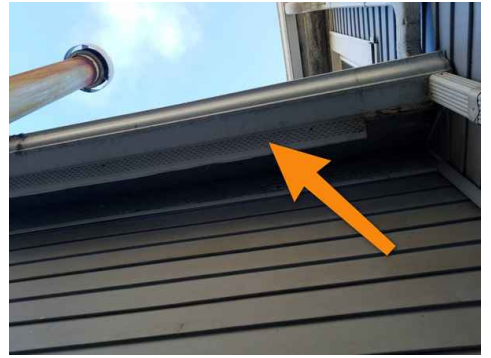
DAMAGE OBSERVED AT FASCIA

I observed indications that one or more areas of the fascia were damaged. This will allow for water or pest infestation.

Recommend a reputable contractor.

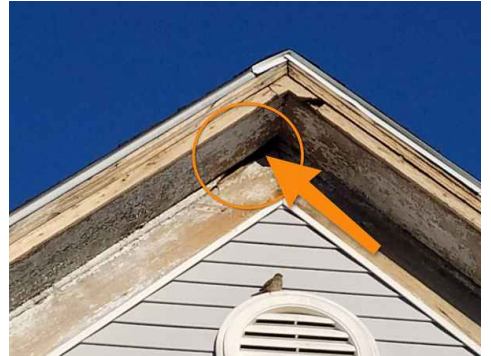
3.2.2 Eaves, Soffits & Fascia

DAMAGE OBSERVED AT SOFFIT

I observed indications that one or more areas of the soffit were damaged. This will allow for water or pest infestation.

Recommend a reputable contractor.

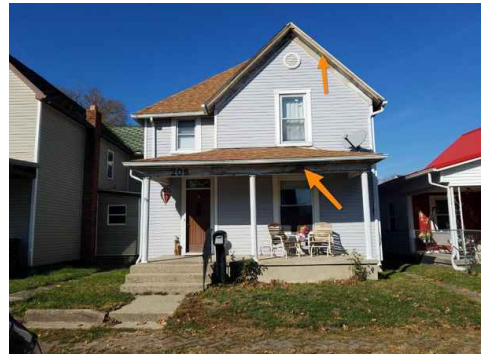
3.2.3 Eaves, Soffits & Fascia

PAINT SURFACE IN POOR CONDITION

I observed indications of paint or staining in poor condition. Flaking, cracking, and worn areas. Recommend a reputable contractor.

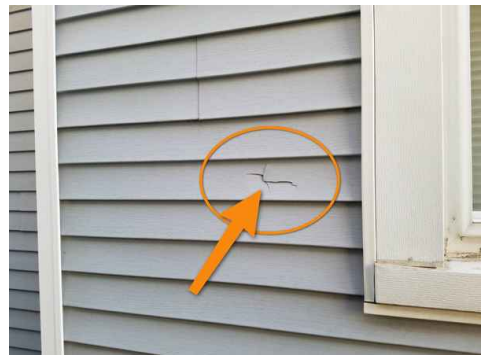
3.3.1 Wall-Covering, Flashing & Trim

DAMAGED WALL-COVERING MATERIAL

One or more areas of damaged wall-covering material. This will allow for water and pest infestation. Recommend a reputable contractor.

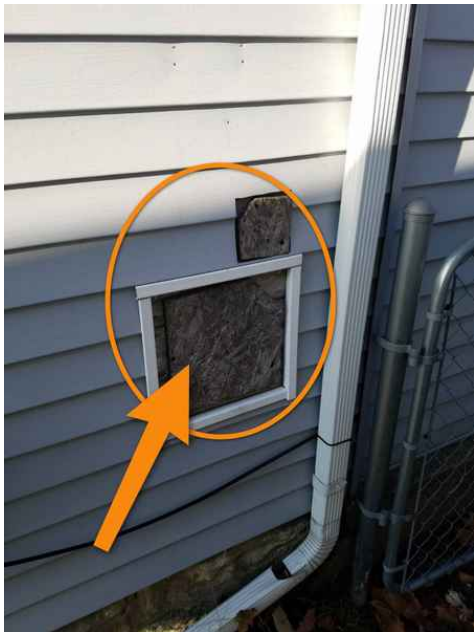
3.3.2 Wall-Covering, Flashing & Trim

MISSING SIDING

Section of siding is missing. This will allow for water and pest infestation. Recommend a reputable contractor.

Right Side of Home

Recommendation
Contact a qualified professional.

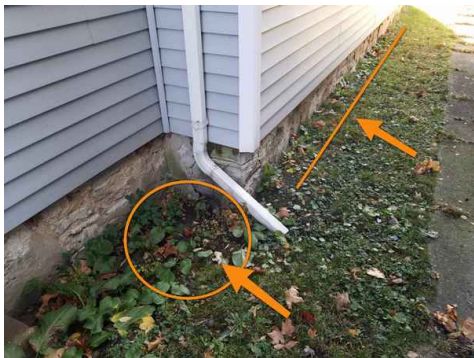
Grading is sloping towards the home in some areas. The ground around a house should slope away from all sides, ideally 6 inches for the first 10 feet from the house foundation perimeter.

This will allow for water penetration to the foundation. Recommend a reputable contractor.

Left Side of Home

Recommendation
Contact a qualified landscaping contractor

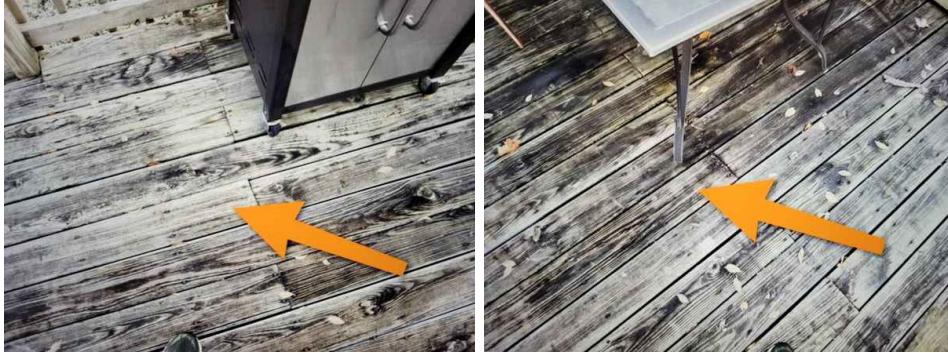
DECK - LOOSE BOARD

I observed a loose board component at the deck. Recommend a reputable contractor.

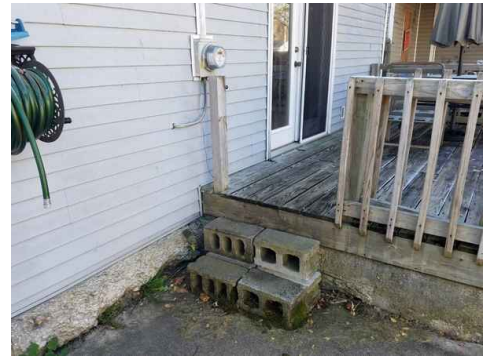
3.5.2 Porches, Patios, Decks, Balconies

DECK WOOD NOT SEALED OR TREATED

Deck boards and railings have not been sealed or stained.

Recommend application of a sealer or stain to prevent weathering and water damage. Continue to monitor.

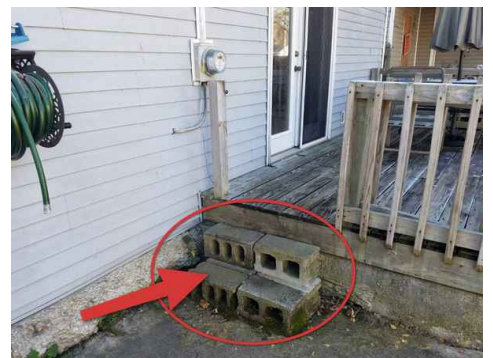
3.7.1 Stairs, Steps, Stoops, Stairways & Ramps

IMPROPER DECK STEPS AND MISSING HANDRAILS.

Noticed improper deck steps and missing handrails and balusters leading to deck. This will allow for a fall or worse. Recommend a reputable contractor.

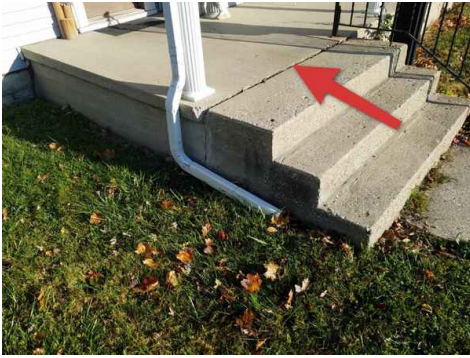
3.7.2 Stairs, Steps, Stoops, Stairways & Ramps

STEP SETTLEMENT

Front cement steps have settled. This is a trip hazard. This will allow for a fall or worse. Recommend a reputable contractor.

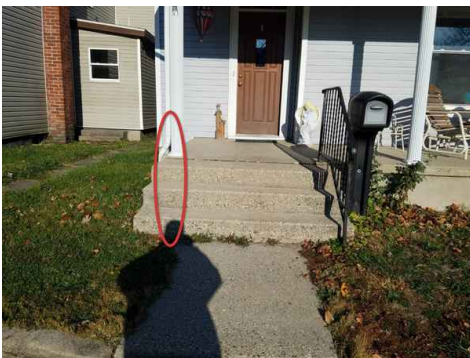
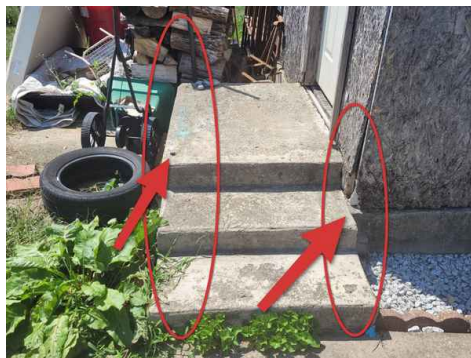
3.8.1 Railings, Guards & Handrails

MISSING HANDRAIL

I observed a missing handrail and balusters at the steps of porch and garage. Fall hazard. This will allow for a fall or worse. Recommend a reputable contractor.

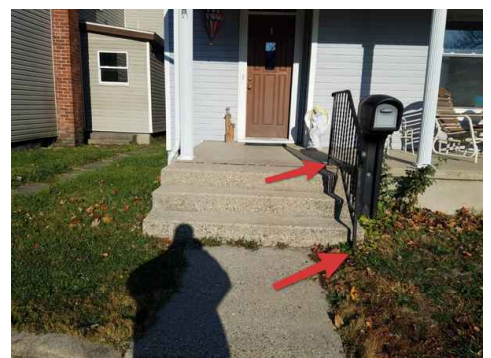
3.8.2 Railings, Guards & Handrails

LOOSE RAILING COMPONENT

I observed a loose railing component on the right side of the porch steps. Fall hazard. This will allow for a fall or worse. Recommend a reputable contractor.

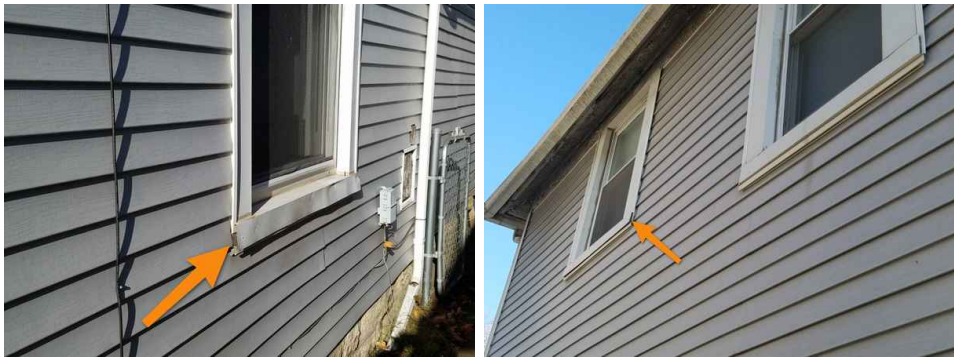
3.10.1 Windows

IMPROPER OR INCOMPLETE WINDOW WRAP MATERIALS.

Noticed one or more windows with improper or incomplete window wrap materials. This will allow for water and pest infestation. Recommend a reputable contractor.

Recommendation
Contact a qualified professional.

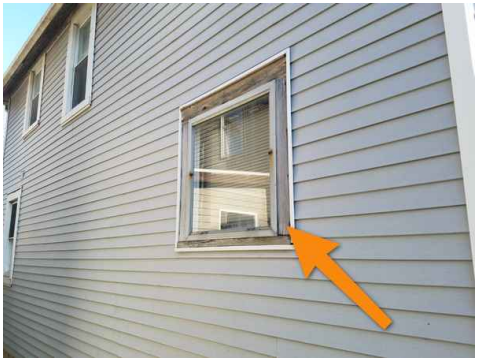
3.10.2 Windows
PEELING PAINT
LEFT SIDE OF HOME

Exterior wood window trim and sash has peeling paint. This will allow for water and pest infestation. Recommend a reputable contractor.

Recommendation
Contact a qualified painting contractor.

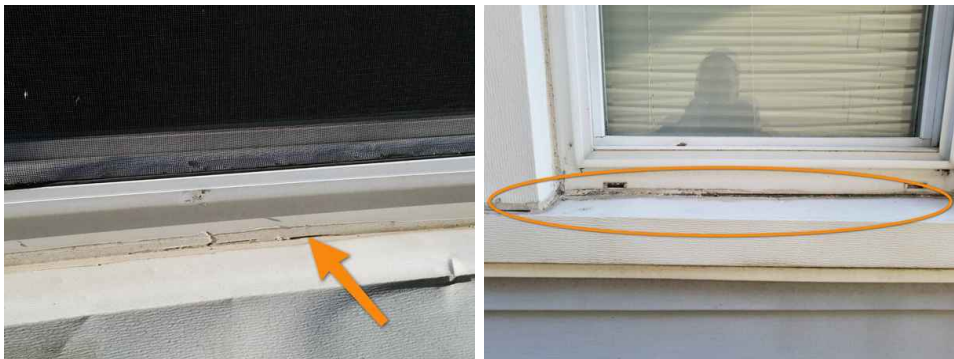
3.10.3 Windows
POOR OR NO CAULK PRESENT AT WINDOW
RIGHT SIDE OF HOME

Noticed one or more windows with either poor or no caulk present. This will allow for water and pest infestation. Recommend a reputable contractor.

Recommendation
Contact a qualified professional.

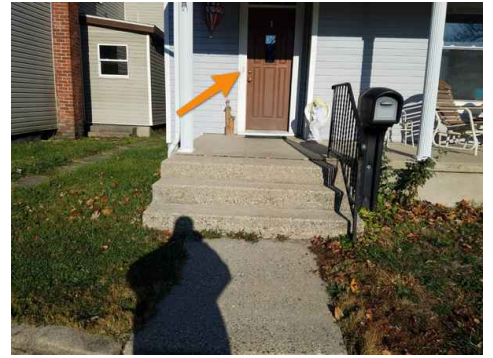
3.11.1 Exterior Doors
DOORBELL DOES NOT RING.
FRONT DOOR

Doorbell does not ring. Recommend a reputable contractor.

Contact a qualified professional.

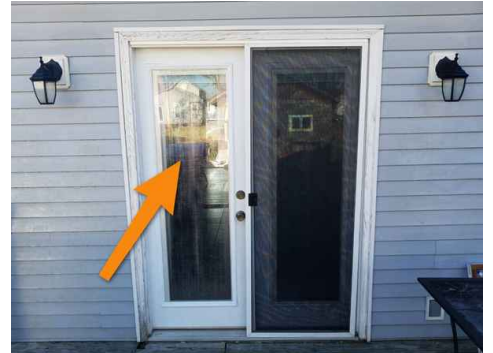
3.11.2 Exterior Doors

FOGGED WINDOW PANE AT DOOR.

I observed a fogged windowpane (a lost seal) at a door.

If multiple-pane windows appear misty or foggy, it means that the seal protecting the window assembly has failed, and condensation has formed in between the two panes of glass. Condensation in double-paned windows indicates that the glazing assembly has failed and needs repair or replacement. Visible condensation can damage glazing and is the main indication of sealant failure.

Condensation is not always visible. If the failure is recent, a failed window may not be obvious, since condensation does not usually form until the window is heated by direct sunlight. Windows in the shade may show no evidence of failure, so it is nearly impossible to observe and report all failed double-paned windows. Recommend a reputable contractor.

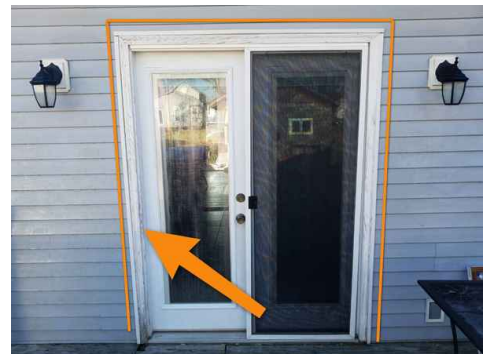
3.11.3 Exterior Doors

PEELING PAINT

Exterior door has peeling paint. Recommend scraping and repainting as needed. Recommend a reputable contractor.

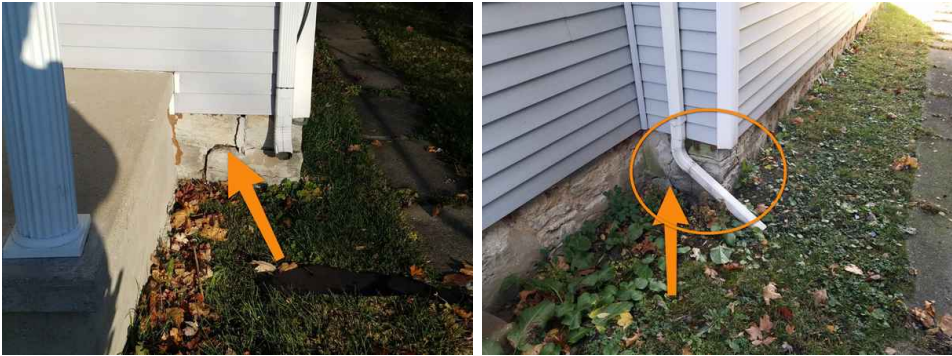
3.14.1 Foundation

CRACKED SPALLING

Noticed settlement cracks and/or spalling at the foundation. This will allow for water and pest infestation. Recommend a reputable contractor.

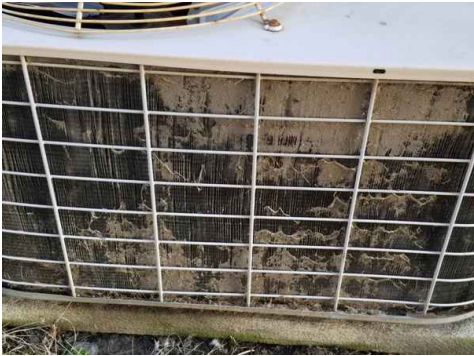
I observed that the air flow to the air conditioner unit was restricted because of dirt and debris. This will ruin the compressor.
Recommend a reputable licensed HVAC contractor.

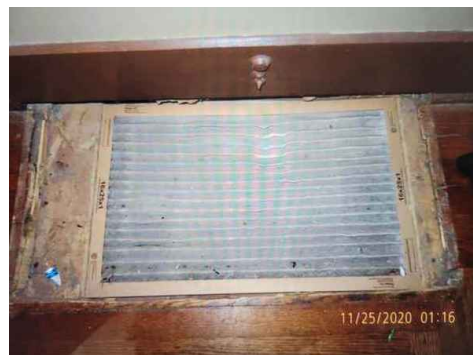
I observed a dirty air filter at the furnace filter. Furnace filters should be checked every 3 months for needed replacement. This will allow for your furnace to be overworked and its efficiency to lower. Recommend replacing the old dirty filter with a new clean filter.

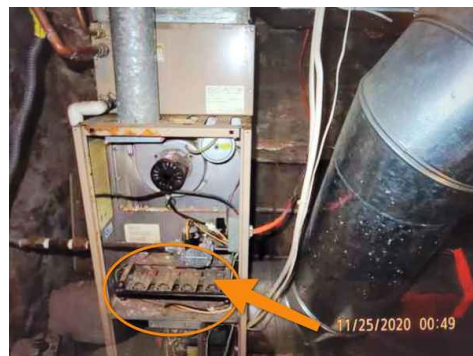
5.1.2 Heating System Information

I observed indications of delayed maintenance at the heating system. The system should be cleaned and inspected by an HVAC professional every year. Recommend a reputable licensed HVAC contractor.

Contact a qualified heating and cooling contractor

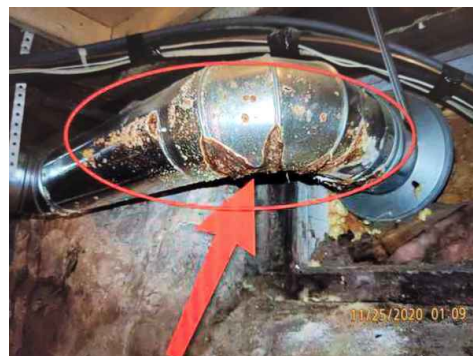
5.1.3 Heating System Information

FLUE PIPE DEFECT

Noticed a defect in the flue exhaust pipe. Corrosion and rust in flue pipe will allow carbon monoxide to escape back into the home. This will allow for injury or worse. Recommend a reputable licensed HVAC contractor.

Contact a qualified HVAC professional.

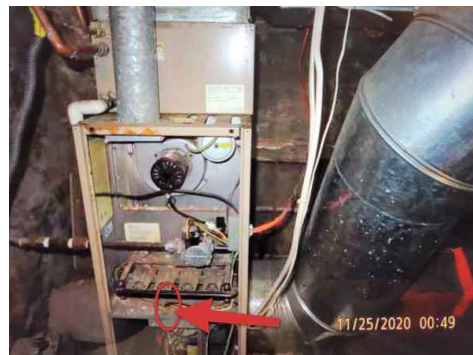
5.1.4 Heating System Information

FURNACE SAFETY SWITCH DEFECT

On inspection of the furnace safety switch, it was noticed that the safety switch was not working properly. Safety hazard. Recommend a reputable licensed HVAC contractor.

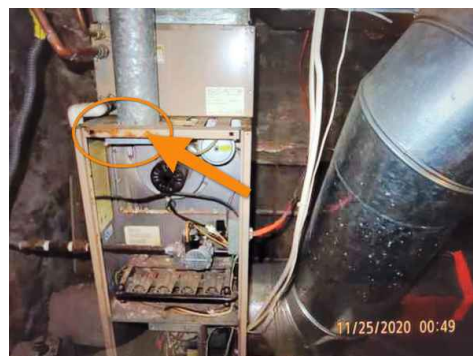
5.1.5 Heating System Information

CORROSION & RUST

I observed areas of corrosion and rust at the heating system. Recommend a reputable licensed HVAC contractor.

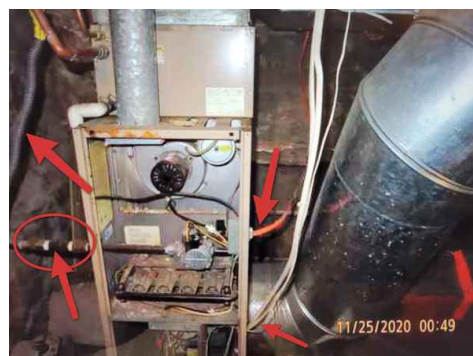
5.1.6 Heating System Information

DEFECT AT HEATING SYSTEM

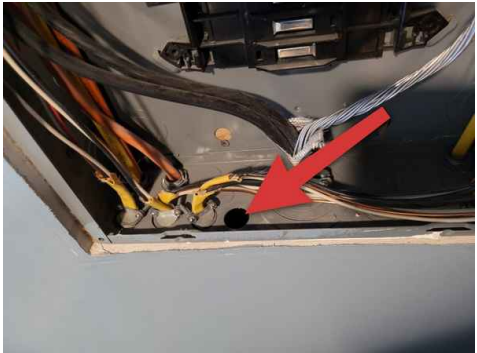
6.5.1 Panelboards & Breakers

KNOCKOUTS MISSING

Contact a qualified electrical contractor.

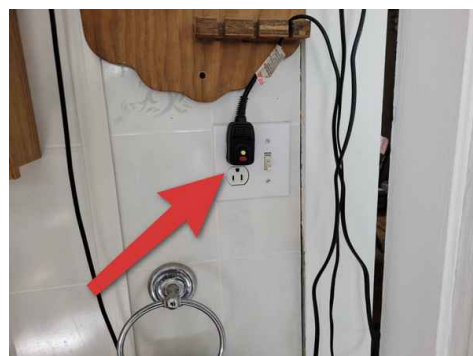
9.4.1 GFCI & Electric in Bathroom

RECEPTACLE IS NOT GFCI PROTECTED

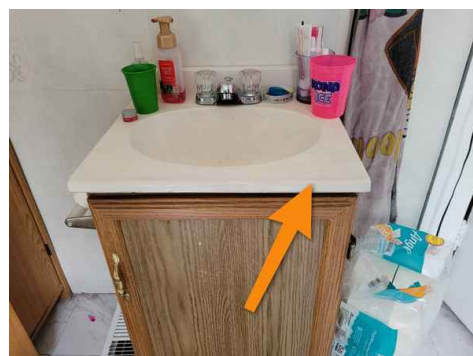
9.6.1 Cabinetry, Ceiling, Walls & Floor

VANITY TOP NOT SECURED

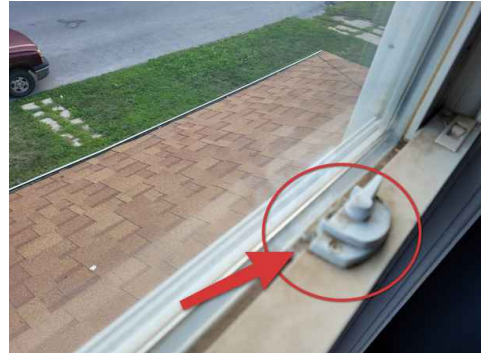
10.2.2 Windows

WINDOW WILL NOT LOCK

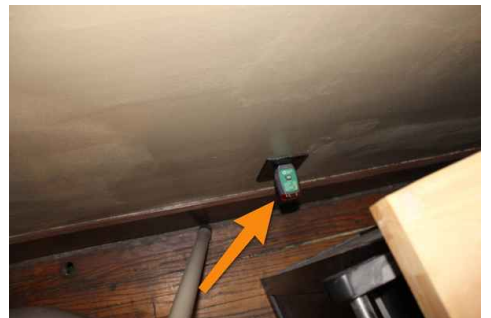
10.3.1 Switches, Fixtures & Receptacles

POWER NOT PRESENT AT RECEPTACLE

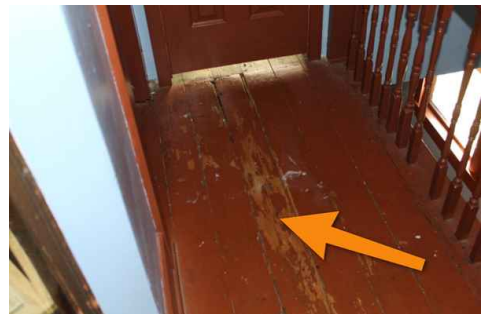
10.4.1 Floors, Walls, Ceilings

LOOSE WOOD PLANKS

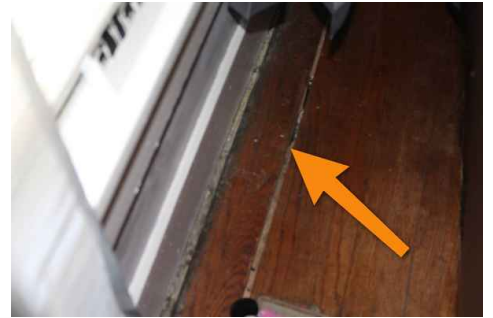
10.4.2 Floors, Walls, Ceilings

WOOD FLOORING SEPARATION

Contact a qualified professional.

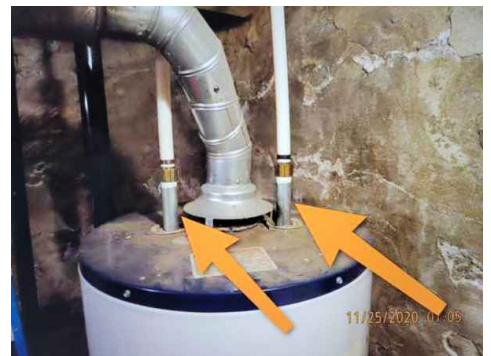
11.3.2 Hot Water Source

PLASTIC PIPES NEXT TO VENT PIPE

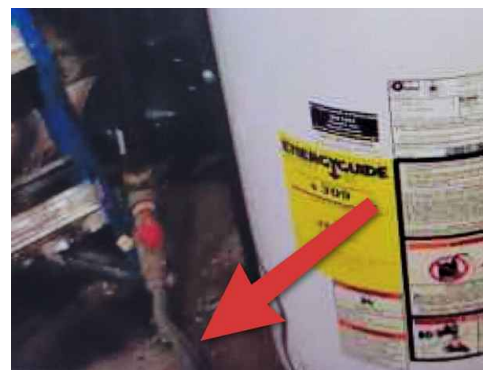
11.3.3 Hot Water Source

FLEXIBLE GAS PIPE

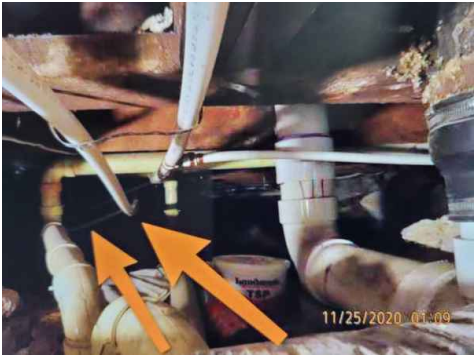
11.5.1 Water Supply & Distribution Systems

IMPROPER INSTALLATION OF WATER PIPES

I observed indications of poor workmanship and improper installation of the water supply pipes. Needing additional support in areas. Recommend a reputable licensed plumbing contractor.

Recommendation
Contact a qualified plumbing contractor.

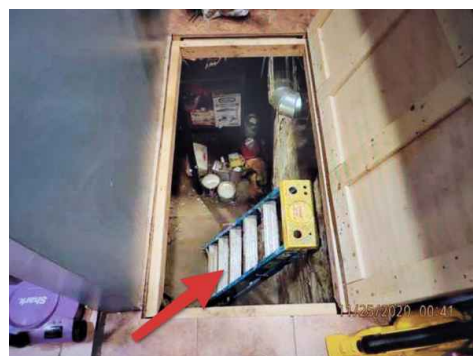
12.1.2 Basement

INSUFFICIENT STAIRCASE LEADING TO BASEMENT

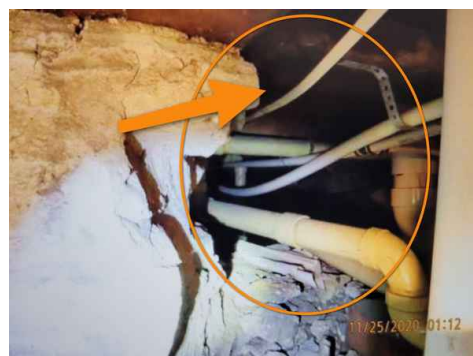
12.3.1 Floor Framing

ABSENCE OF INSULATION WITHIN FLOOR FRAMING

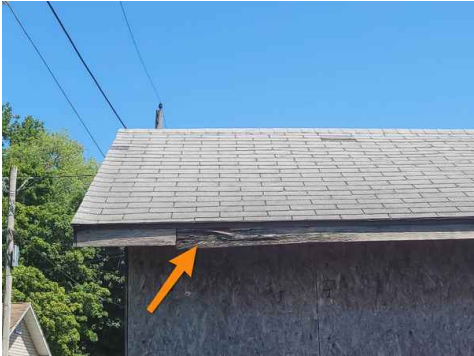
14.9.2 Garage exterior

DAMAGE TO WOOD TRIM

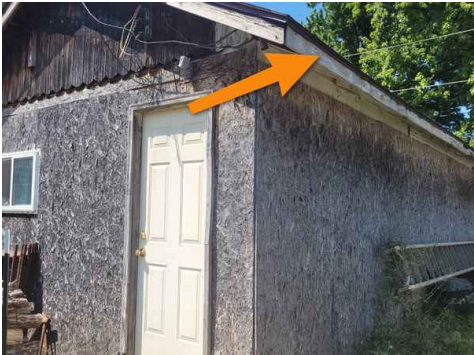
14.11.1 Garage roof

MISSING GUTTERS

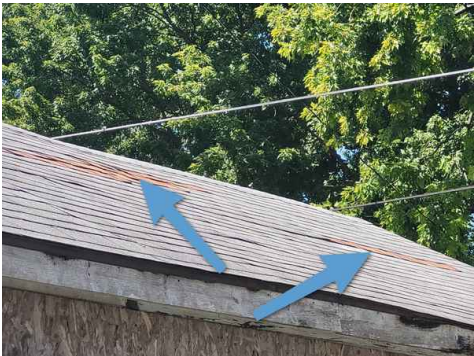
14.11.2 Garage roof

SHINGLE REPLACEMENT/PATCH

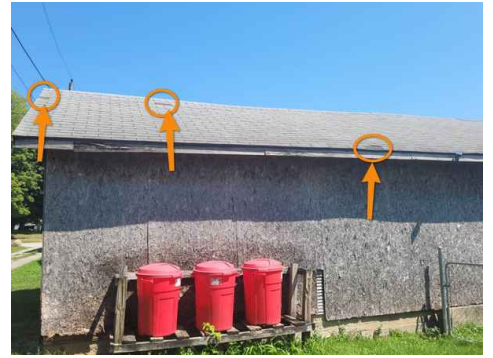
14.11.3 Garage roof

MISSING SHINGLES

Contact a qualified professional.

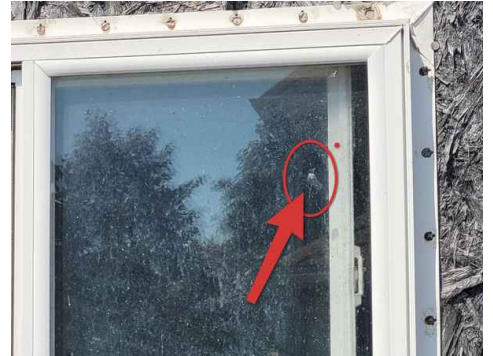
14.12.1 Garage windows

BROKEN WINDOW

Contact a qualified professional.
